iWT³ Wheel Damage Problems

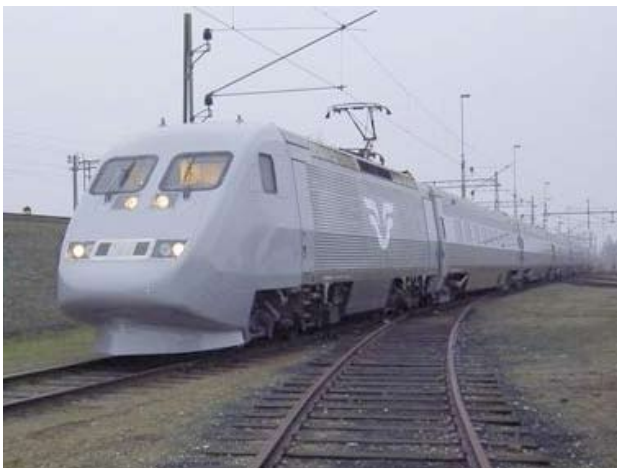
Interfleet's third generation Instrumented Wheelset Technology provides essential data for solving wheel damage problems. The wheel sets are used to measure vertical and lateral forces between wheel and rail.

The high force strain from these defects is easily detected in our test run diagrams.

Interfleet was contracted by SJ to investigate these problems. Using the technique to measure wheel/rail forces - up to 2000 Hz - we showed that fatigue cracks might well develop into fractures, because of e.g. discontinuities, local rail defects and rail surface corrugation.
